ALCESTER TOWN COUNCIL
LEAD COUNCILLOR REPORT

TOPIC: Footpaths

DATE: 27/03/26

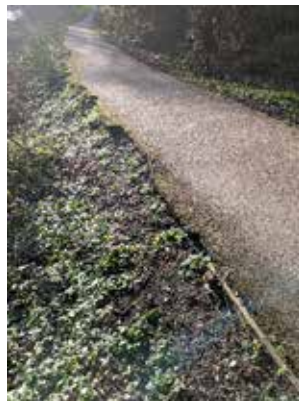
1. Jubilee Fields

The repairs to the top end of the path have held well and overall, the footpath from the orchard to the end of the grassy area heading for the Greig Hall is in good condition. Unfortunately, the footpath between this point and the marker is now showing signs of being undermined and breaking up – see picture below.

Category A, but the part of the path mentioned above needs to be kept under review.

1. Visit to Westbury Park to conduct Risk Assessment on the informal entrance, accessible entrance and uneven areas along the path by the river.
2. Progress survey currently underway to determine repairs and cost of work to the Cemetery path around the gates.
3. Inspect path beside river at Greig Hall end of Jubilee Fields.
4. Inspect path running from end of Bleachfield Road alongside Bleachfield Park.
5. Formal inspection to all paths to be repeated in 6 months.

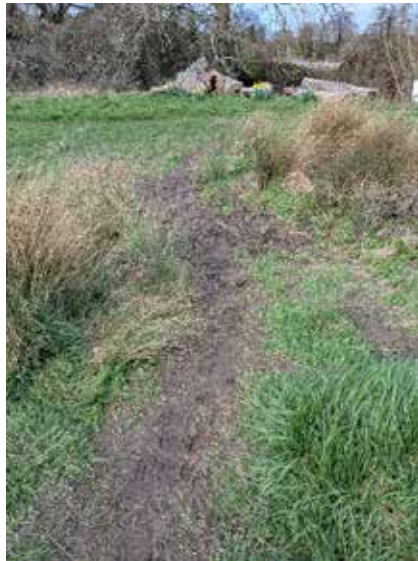
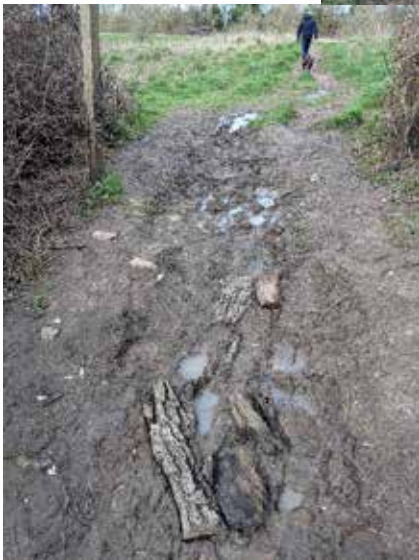
2. Abbey Fields

The recent visit found the footpath to be in a poor condition due to the period of wet weather. Many areas along the path were found to be extremely difficult to negotiate with extreme care being required. I am sure as the weather improves it will start to dry out and become less difficult to use.

Start of path into nature reserve is very uneven (not ATC responsibility)

Overall condition remains at Category B.

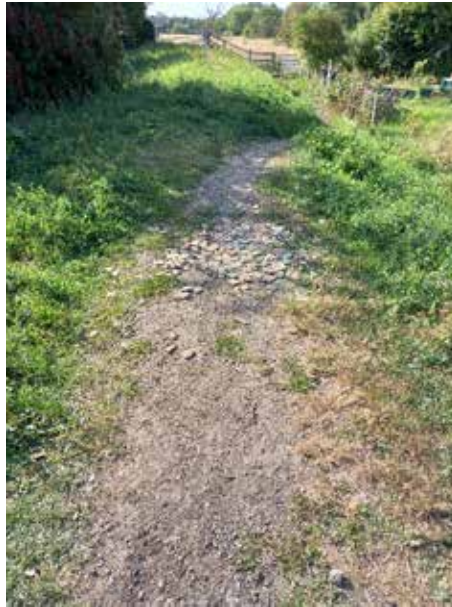
3. Allotment Path (between School Road and Abbey Fields)

This continues to be very uneven and difficult to walk on. Fortunately, it is only a very short expanse of path.

Overall condition remains at Category C.

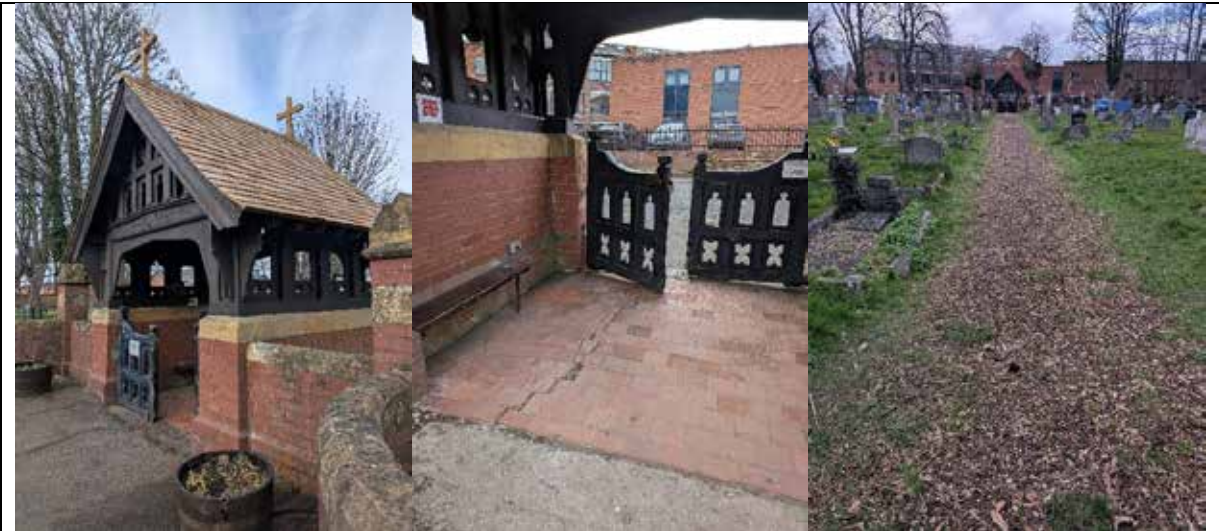
4. Cemetery Path

As the pictures below show repairs to the roof of the lychgate have been completed and the result is excellent. The replacement of the gates is planned to commence soon. The path under the lychgate is in a poor condition, however investigation has now commenced into how and when the path is repaired. The path through the cemetery is in a good condition benefiting from the use of wood chippings as required.

Overall condition remains at category B.

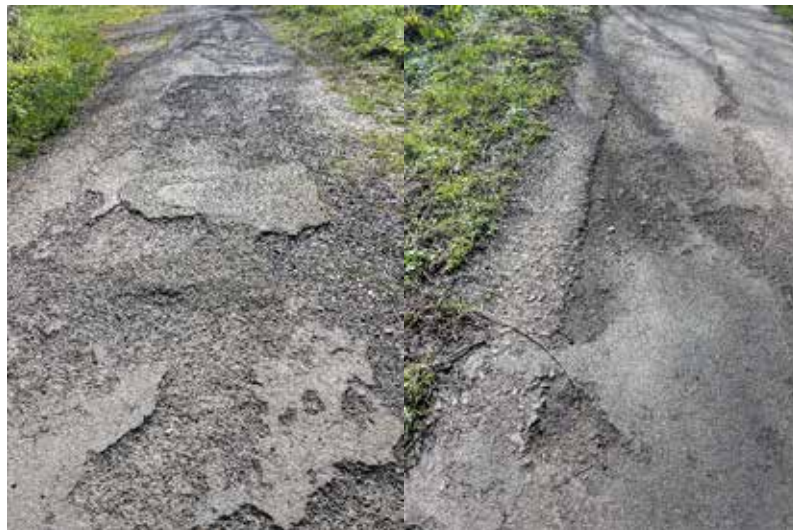
5. Bleachfield Street Swing Park Access

Since the last inspection in August there has been some deterioration to the condition of the surface of the path. It is recommended that it is assessed periodically and considered for future repairs.

Remains category B.

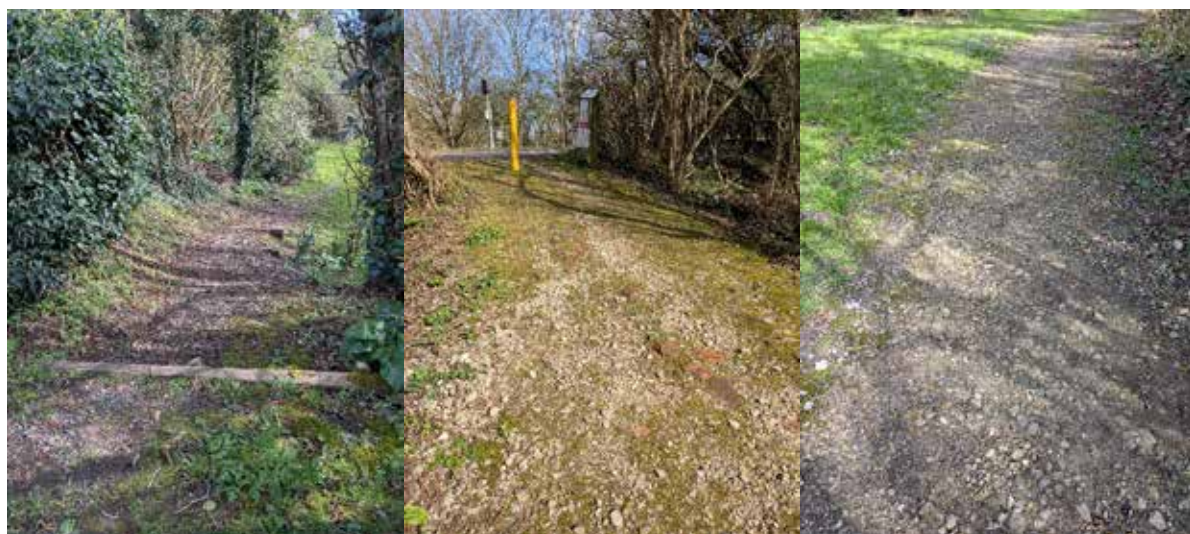
6. Westbury Park

The informal access to the park (nearest the Birmingham roundabout) is uneven and quite difficult to negotiate (left picture). The middle entrance from the Arden Road appears to be intended to be accessible however the condition of the surface is such that inspection for repair is required (middle picture).

The path through the park is 'lumpy' and consideration should be given to levelling areas where this is particularly noticeable (eg right hand picture).

Condition has worsened to category C.
